CHALLENGES OF A HISTORIC RENOVATION

Converting the Bank Building at Chestnut Street presents difficulties for the design/build team.

by Stephen Ziga, CPD, CET

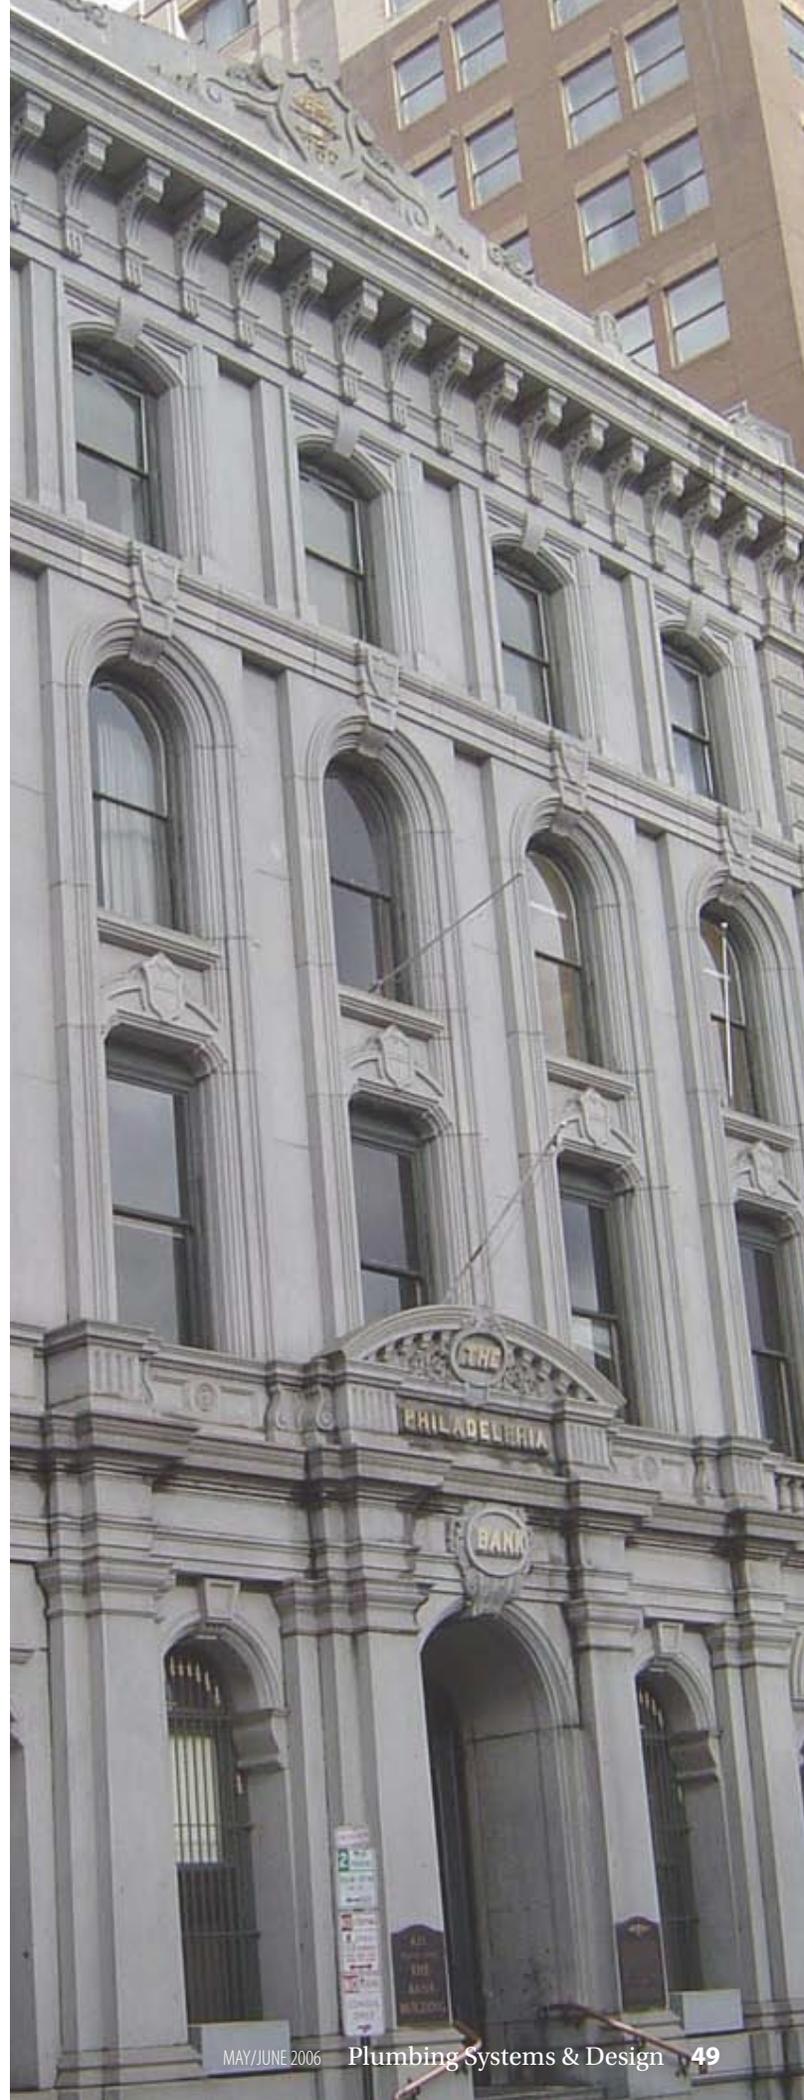
Figure 3 In the existing historic area, the cement open structure with plaster architectural details limited the amount of pipes passing through open areas.

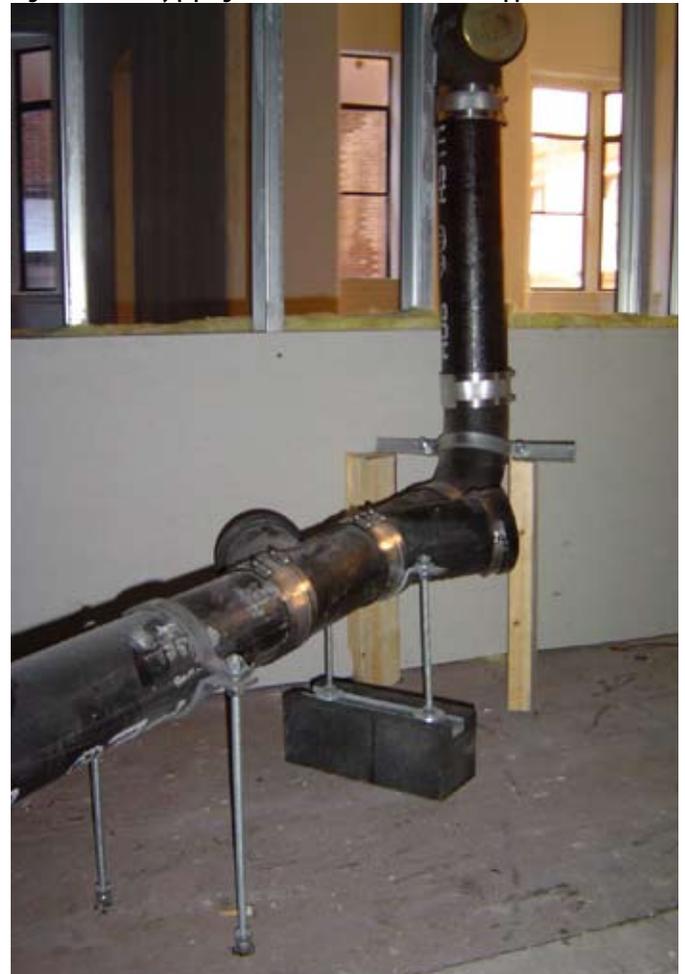
Figure 4 Sanitary piping installed below a raised floor application

The original sanitary drainage design had only provided for a central toilet core at each floor level. Only one 4-inch sanitary stack existed. Since no sanitary drainage piping was to run horizontally on the first floor, we decided to raise the second floor level and provide the new sanitary service beneath it. We designed the new sanitary system to reuse the existing service and provided a new 6-inch horizontal main that was to be routed beneath the raised floor (see Figure 4). This new main would pick up the additional sanitary risers that were required for the fixtures on the floor above. (When working with residential design, it is important to tell the architects where you are running any piping larger than 3 inches so they can provide walls deep enough to contain the piping.)

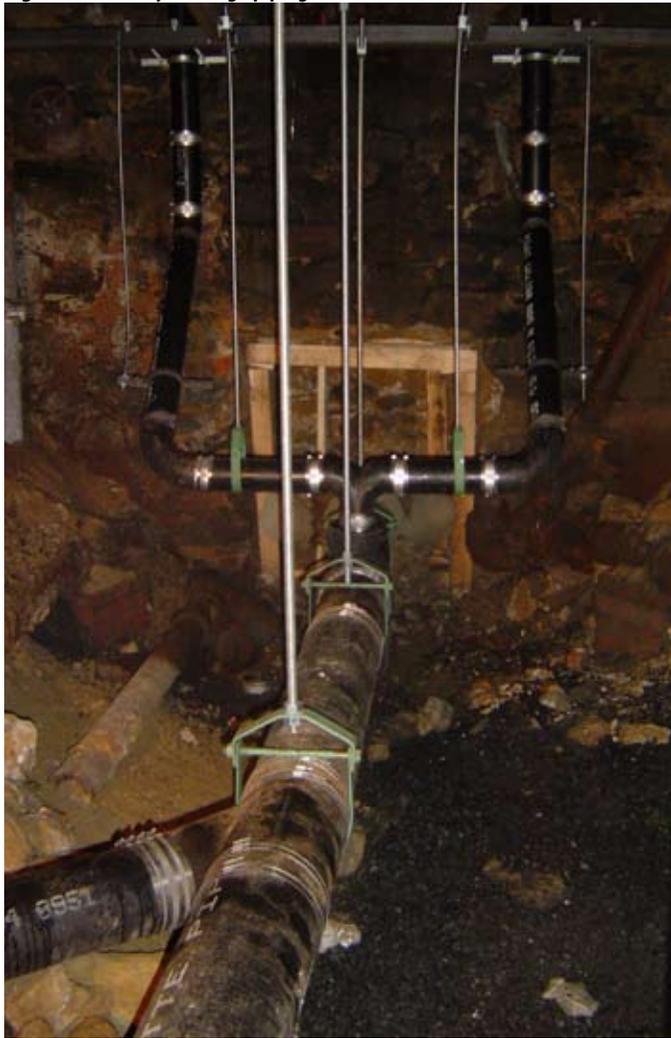
Figure 6 Sanitary drainage piping

Figure 6 shows the exit point for the combined sanitary and storm drainage system. The piping passes through an existing coal storage area. The depth of the piping and passage through the existing brick foundation made the installation more challenging.

The redesign of the sanitary service and storm water service added great expense to the project due to the need to route through existing concrete and masonry conditions and relocate piping to provide proper head clearances (see Figure 6). This might have become a much larger issue had it not been identified early in the project. (It is important to understand the head clearance of the piping and what impact the slope may have on the area beneath the pipe. It is also important to consider how large piping or equipment will be brought into the building. Can you easily get the piping to the area of construction?)
